[Docket No. 2003-NE-52-AD Amendment 39-13410; AD 2003-24-12R1]

Airworthiness Directives; Pratt & Whitney JT9D-3A, -7, -7A, -7F, -7H, -7AH, and -7J Turbofan Engines

2003-24-12R1 Pratt & Whitney: Amendment 39-13410. Docket No. 2003-NE-52-AD. Revises AD 2003-24-12, Amendment 39-13381.

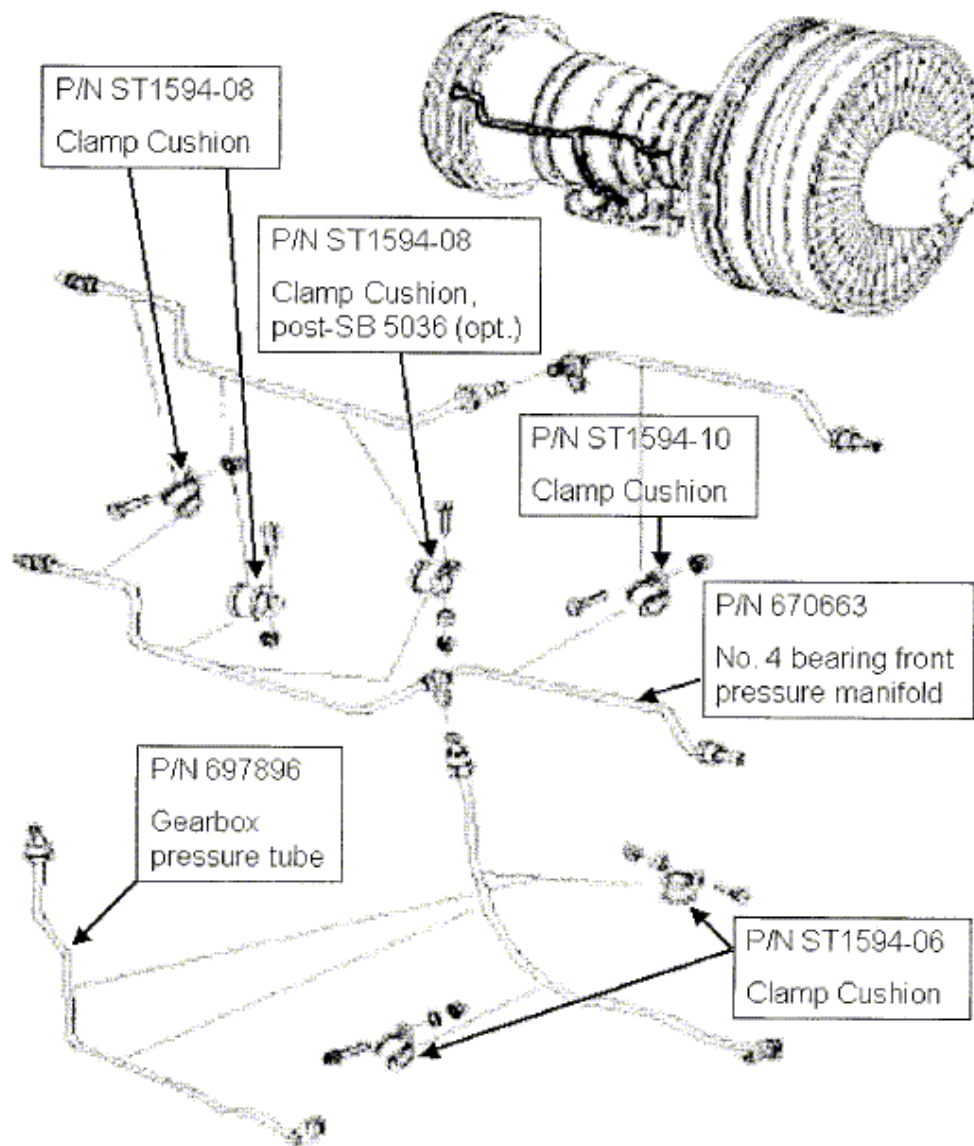
(f) Visually inspect the clamp assemblies, P/Ns ST1594-06, ST1594-08, and ST1594-10, (see Figure 1 of this AD) that attach the gearbox pressure tube and the No. 4 bearing front pressure manifold to the engine. Replace clamp assemblies before further flight that are rejected by any of the following rejection criteria:

- (1) Cracks, wear, or distortion in clamp metal.
- (2) Clamp cushions that are worn, compacted, cracked, coming apart in chunks, deteriorated, or missing. A reddish powder found around the clamp is an indication of deterioration.

Visual Inspection of Gearbox Pressure Tube and No. 4 Bearing Front Pressure Manifold

(g) If one or more clamp assemblies are rejected as described in paragraph (f) of this AD, or out of position or missing (see Figure 1 of this AD), clean any debris and oil from the outer surface of the gearbox pressure tube and No. 4 bearing front pressure manifold and visually inspect the tube and manifold. Repair or replace the affected tube or manifold before further flight if it is rejected by any of the following rejection criteria:

- (1) Nicks, chafing, scratches, and or pitting 0.003 inch or greater in depth.
- (2) Dents within 0.25 inch of the ferrules or will not permit free passage of a ball having a minimum diameter of 80% of the tubing inner diameter.
- (3) Corrosion that is unable to be removed by a light polishing.
- (4) Tube or manifold is leaking oil.
- (5) As an option to the dent inspection method specified in paragraph (g)(2) of this AD, measure tube dent depth and use the following rejection criteria:

- (i) Dents in the gearbox pressure tube, P/N 697896, greater than 0.055-inch depth.
- (ii) Dents in the No. 4 bearing front pressure manifold, P/N 670663, forward of the tee fitting, greater than 0.100-inch depth.
- (iii) Dents in the No. 4 bearing front pressure manifold, PN 670663, aft of the tee fitting, greater than 0.080-inch depth.

- (h) Ensure that the gearbox pressure tube, No. 4 bearing front pressure manifold, and clamp assemblies are properly positioned, before further flight, as shown in Figure 1 of this AD.
- (i) Information on general inspection of these parts can be found in the Boeing 747 Aircraft Maintenance Manual, section 72-00-00, and in PW Standard Practices Manual, P/N 585005.
